WL-TR-96-4030

**PROCEEDINGS OF
THE 1994 USAF
STRUCTURAL INTEGRITY
PROGRAM CONFERENCE**

USAF Structural Integrity Program Conference
Hyatt Regency
San Antonio, Texas

Final Report for Period 6 - 8 December 1994

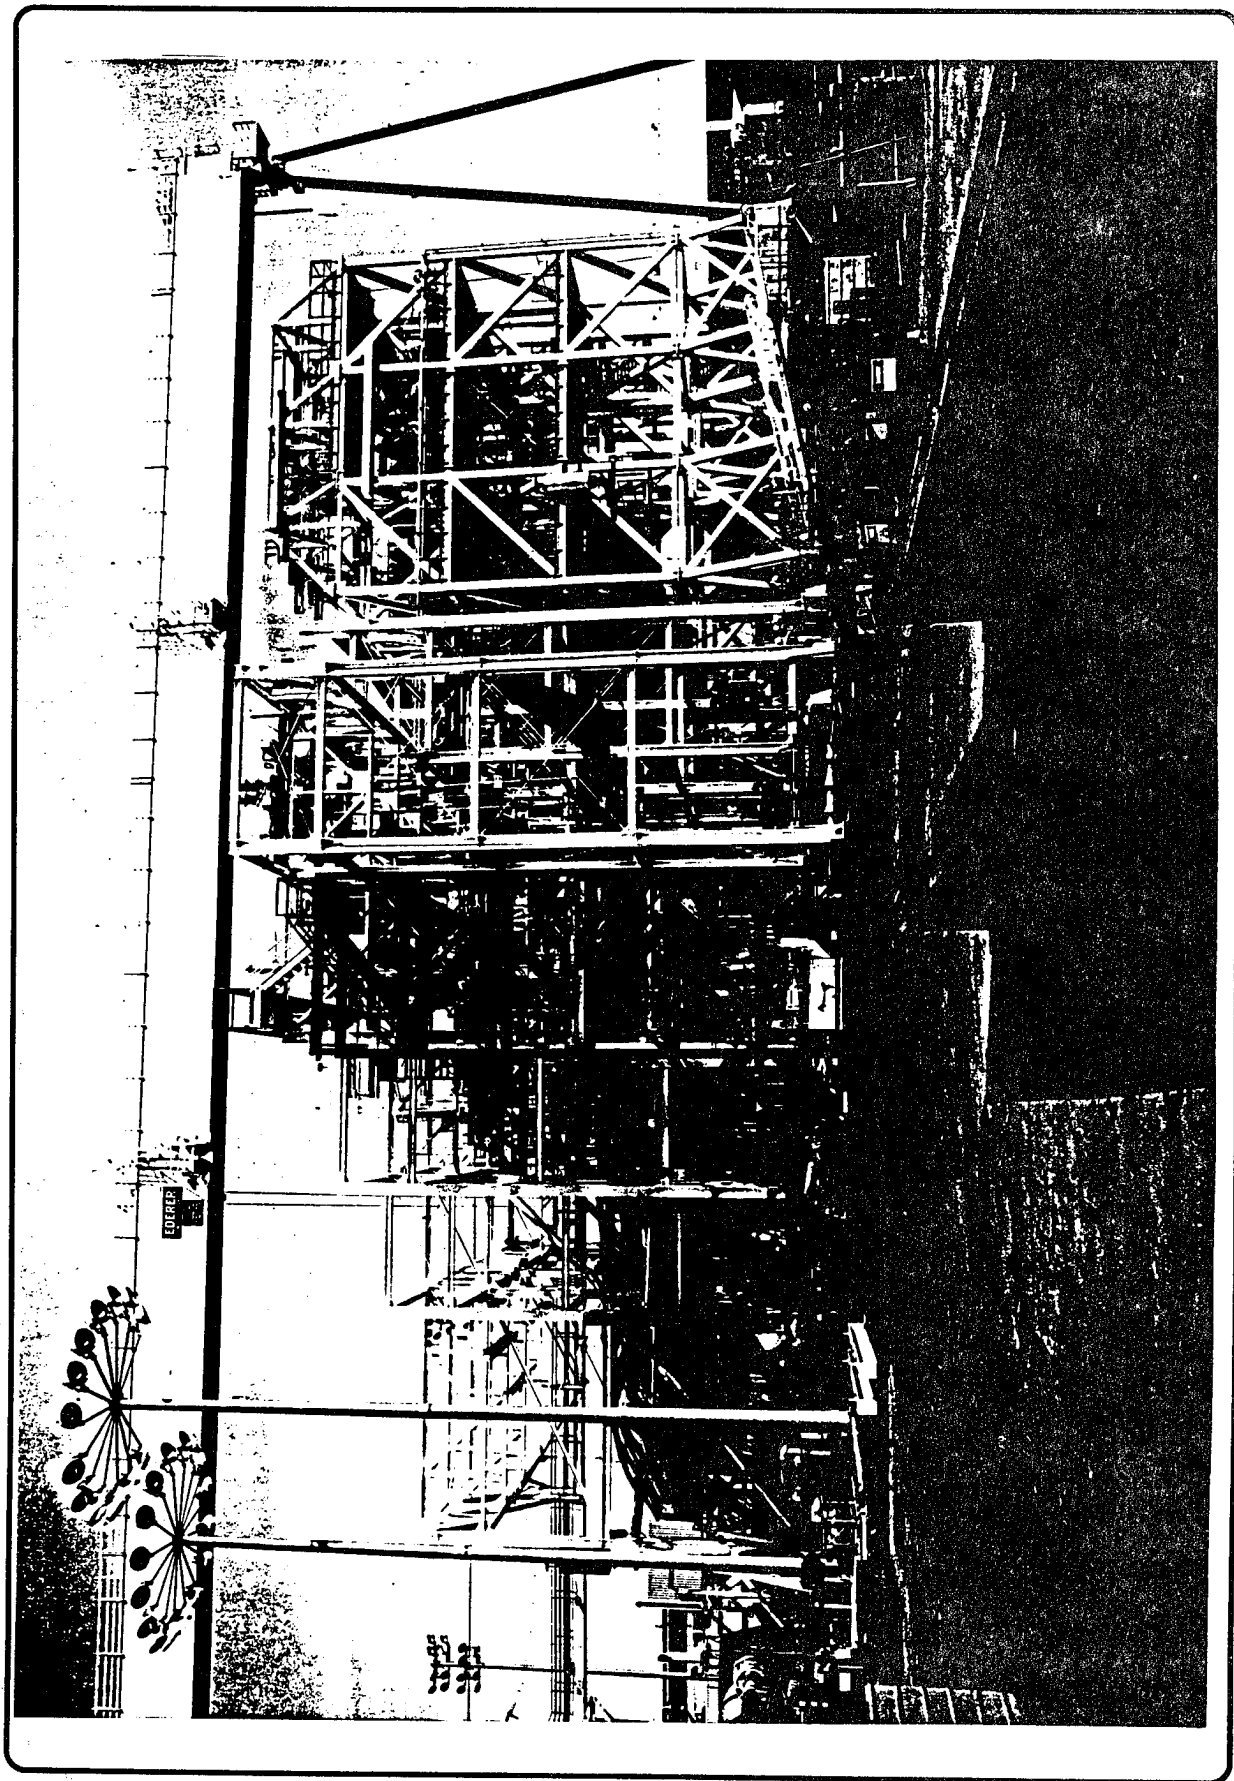
C-17 DURABILITY AIRFRAME

C-17 airframe durability is being verified by testing of the fifth airframe to be assembled. The test article is designated D1 and consists of the fuselage (including main landing gear pods and right hand side wing-fuselage fairings), wing (including fixed leading edge), wing pylon stubs, left hand outboard pylon, and vertical stabilizer. Production slat tracks, upper landing gear assemblies, left hand winglet, and ailerons are also included to provide realistic loading of the article.

The D1 test is being conducted in Long Beach, California in a fixture that is located outside. The systems have been weather proofed and weather conditions have made only a minor impact on running the test even though the article and systems are completely exposed. The article was finished with exterior epoxy primer prior to delivery to the test site. The article is surrounded by a super structure which provides support to the article as well as anchor points for tension actuators. This super structure also facilitates access to the article for inspections and repairs. The fuselage is pressurized without any volume reduction. This facilitates access to the interior for inspection and repair.

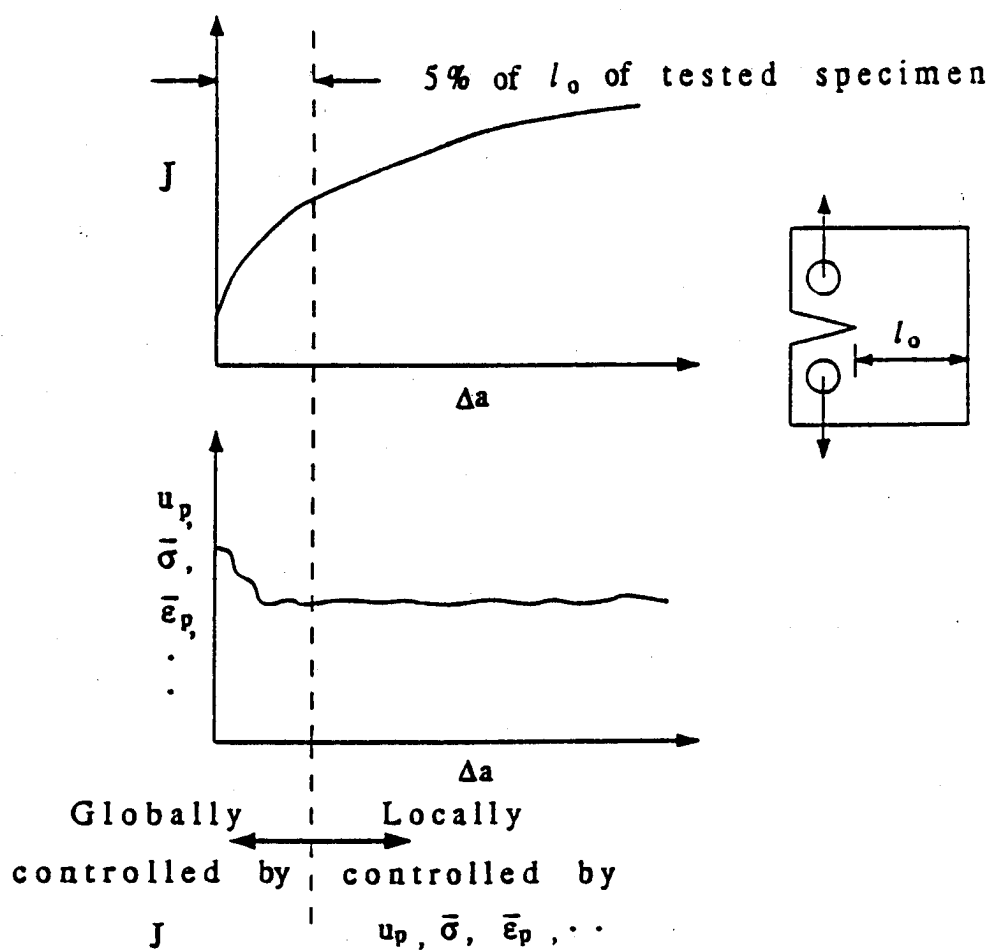
Schematic of GLFC methodology.

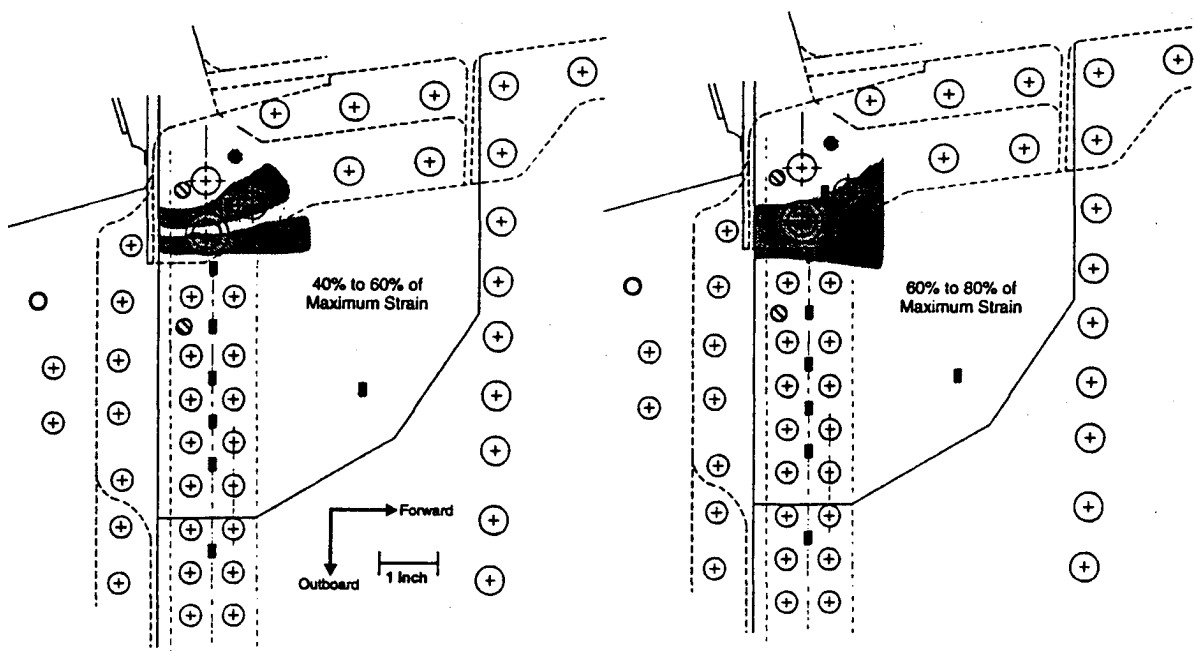
Figure 9 Degradation of the first boron-epoxy repair patch during step loading. The shaded areas indicate the acoustically active zones which are interpreted as the degradation zones.

Figure 9 shows the occurrence of acoustic emission signals as a function of upper wing skin strain up to 80% of 7 g loading for the first repair patch. Acoustic emission signals result from degradation of the patch and the adhesive bond. Figure 9 also shows the location of the initially detected damage at 40% of maximum loading and the spatial extent of the damage at the highest maximum applied step load (80% of 7 g). Examination of the repair patch by the National Research Council of Canada (NRC), Institute for Aerospace Research (IAR) showed damage and decohesion consistent with the acoustic emission results. The condition of the patch and bond were such that it was replaced by a second patch which was tested and fatigued for 7,000 EFH. Acoustic emission monitoring of the initial static loading of the second boron-epoxy repair patch was much more comprehensive than for the first repair patch due to the success of acoustic emission at identifying the damage area and the precise loading conditions at which damage occurred. Figure 10 shows the acoustic emission sensor array used to monitor the integrity of the entire second repair patch during the initial step loading. Sensor pairs were used to monitor the edges of the patch and the group of three fasteners. Figure 10 also shows the acoustic emission activity as a function of upper wing skin strain for the edge of the patch. No significant activity was detected from the vicinity of the three fasteners which is the location of primary concern. Figure 11 shows the area of degradation during subsequent fatiguing for 3,000 EFH. Examination of the repair patch by NRC/IAR showed damage and decohesion consistent with the acoustic emission results [14, 15]. The wing, with installed repair patch, was monitored continuously for a total of 7,000 EFH without incident. Metallographic analysis of the EDM notch has not been carried out at this time.

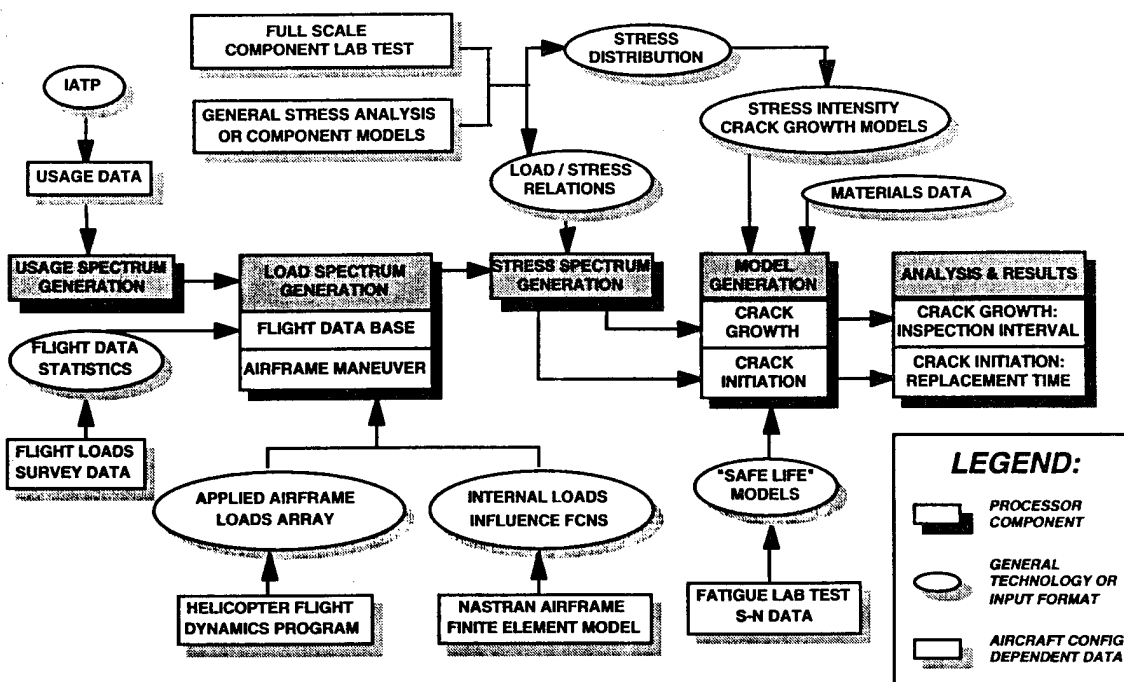
Figure 2. Structural Integrity Computer Program Architecture.

Figure 2 illustrates how the computer program will function. All tasks are brought together graphically to provide a clear picture of their interactions. There are six basic steps to the processor, as labeled by the dark shaded boxes. First, usage spectrum generation is either based on a generalized spectrum for the entire fleet, or tailored for an individual aircraft through the use of an individual aircraft tracking program (IATP). For the selected components, accurate stress spectra will be developed utilizing cycle counted flight test measurements or stress analysis. To permit the calculation of stress spectra for mission segments not included in flight tests, a CAMRAD rotor/fuselage loads model is being correlated to flight test measurements to

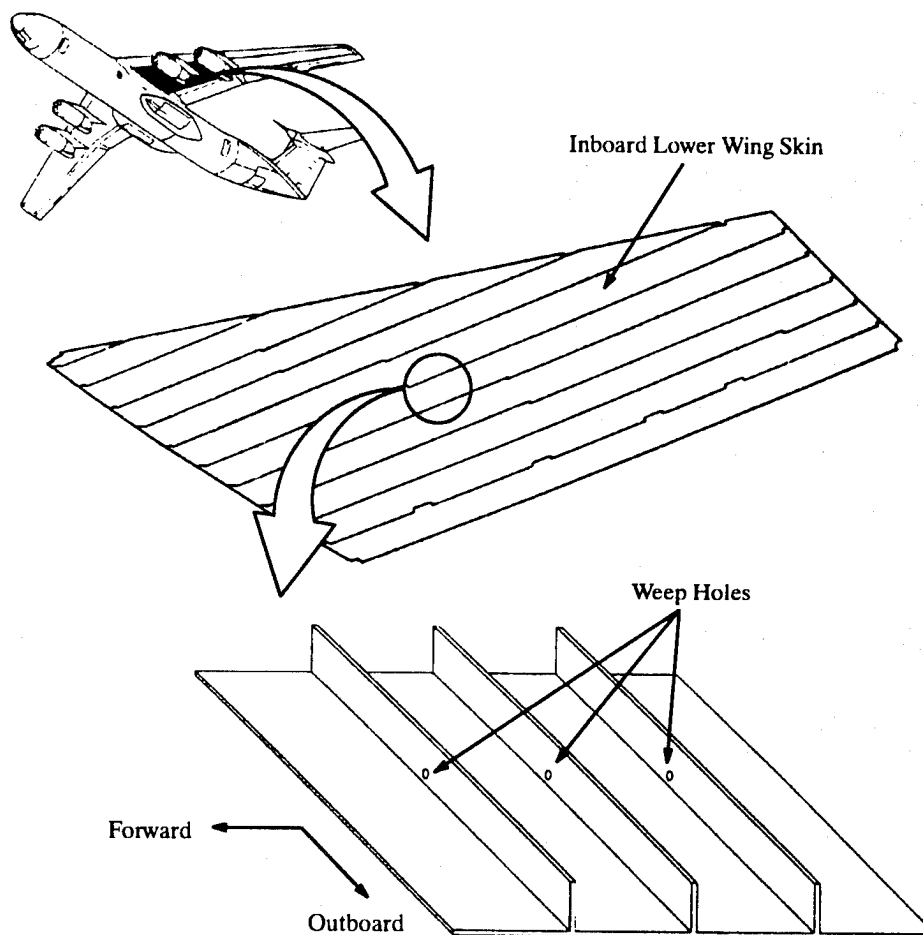
FIGURE 1.1: LOCATION OF THE WEEP HOLES ON THE C-141

1.3 The first weep hole cracks were discovered in July 1977 by Lockheed during a full scale fatigue test. The cracks were found during pass 32, after 96,000 cyclic test hours. Three cracks were found with a visual inspection, while eleven more were discovered using a bolt hole eddy current inspection. Because of those cracks, the weep holes of four operational aircraft were inspected in July 1978 during depot maintenance. No cracks were found during those inspections. In May 1979, three more cracks were found in the fatigue test specimen's weep holes. Inspection requirements and guidelines were recommended by Lockheed. Further weep hole inspections of operational aircraft were performed that year, but no cracks were discovered.

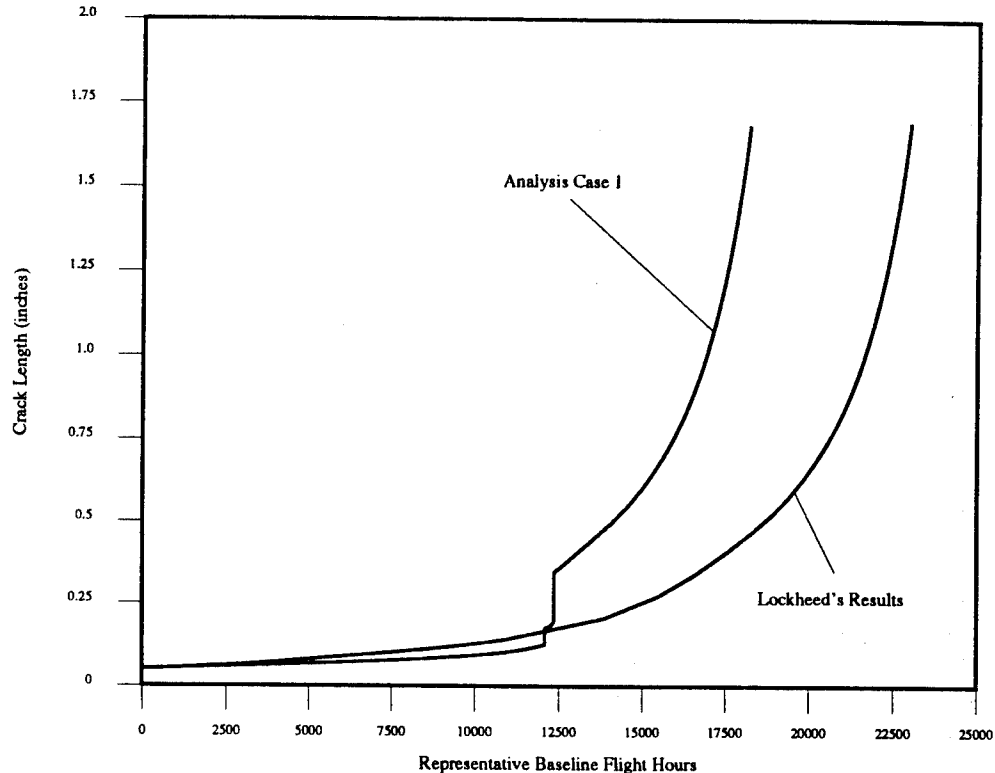
Figure 3.1: Crack Growth Curve for Analysis Case 1 and Lockheed's Results

DAMAGE TOLERANCE ANALYSIS RESULTS		
ANALYSIS CASE #	CRITICAL CRACK LENGTH (inches)	SAFETY LIMIT (flight hours)
Lockheed's Results	1.693	22,977
1	1.683	18,195
2	2.570	17,679
3	≈ 4.00	608,141
4	≈ 4.00	1,058,901

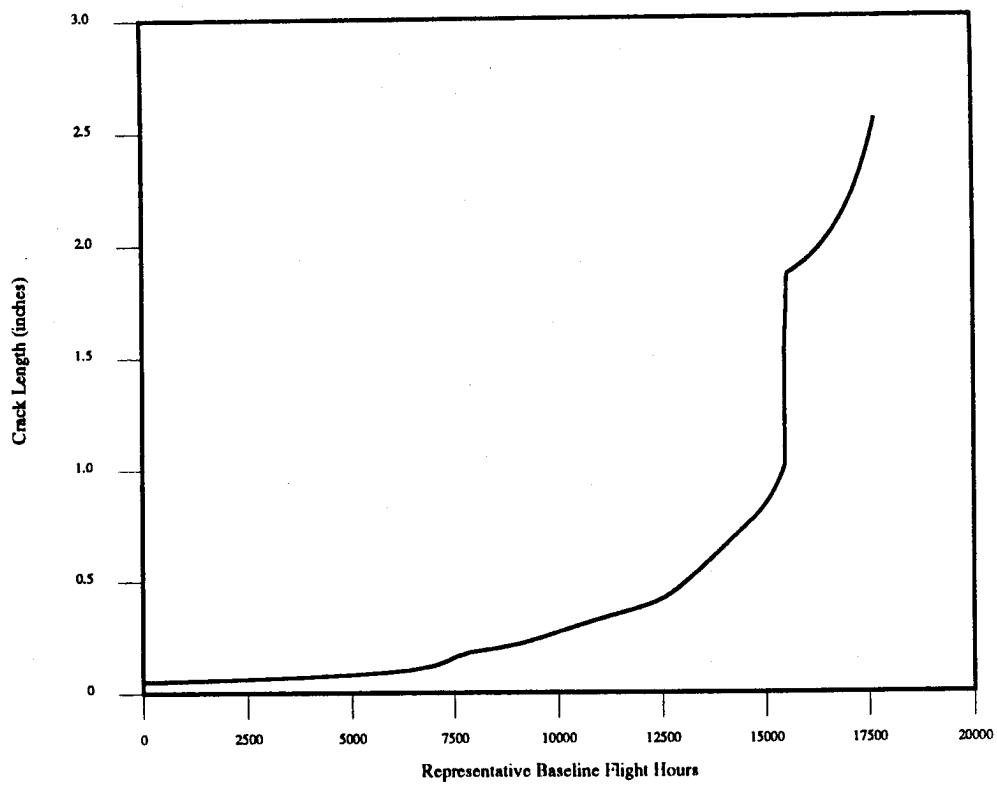
Figure 3.2: Crack Growth Curve for Analysis Case 2

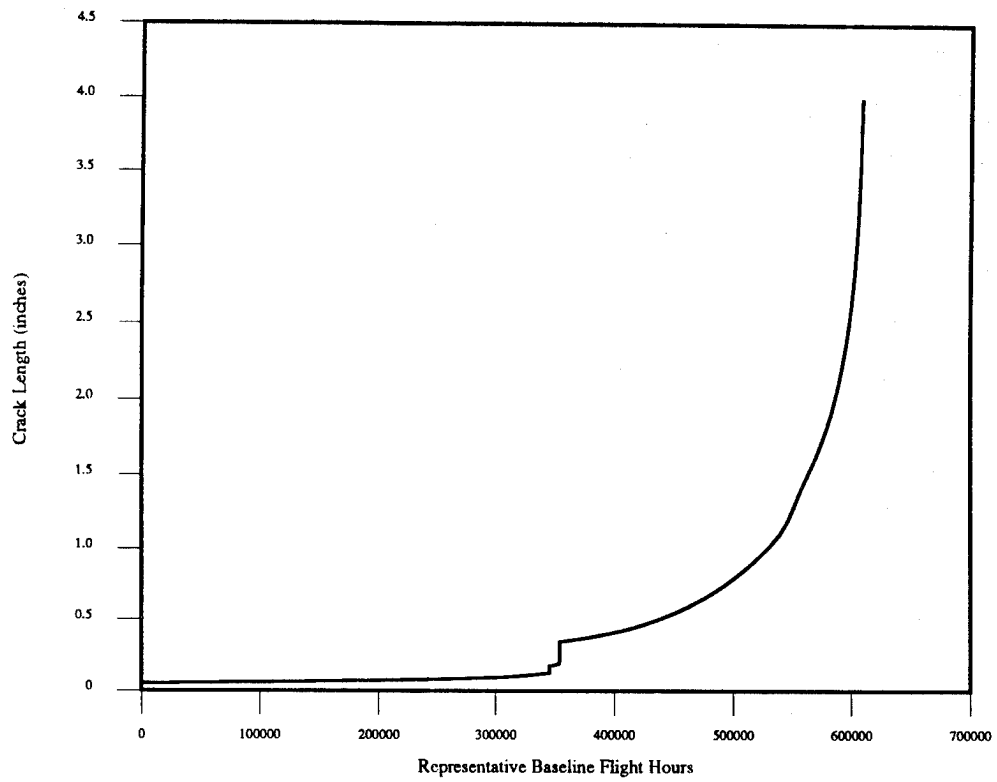
Figure 3.3: Crack Growth Curve for Analysis Case 3

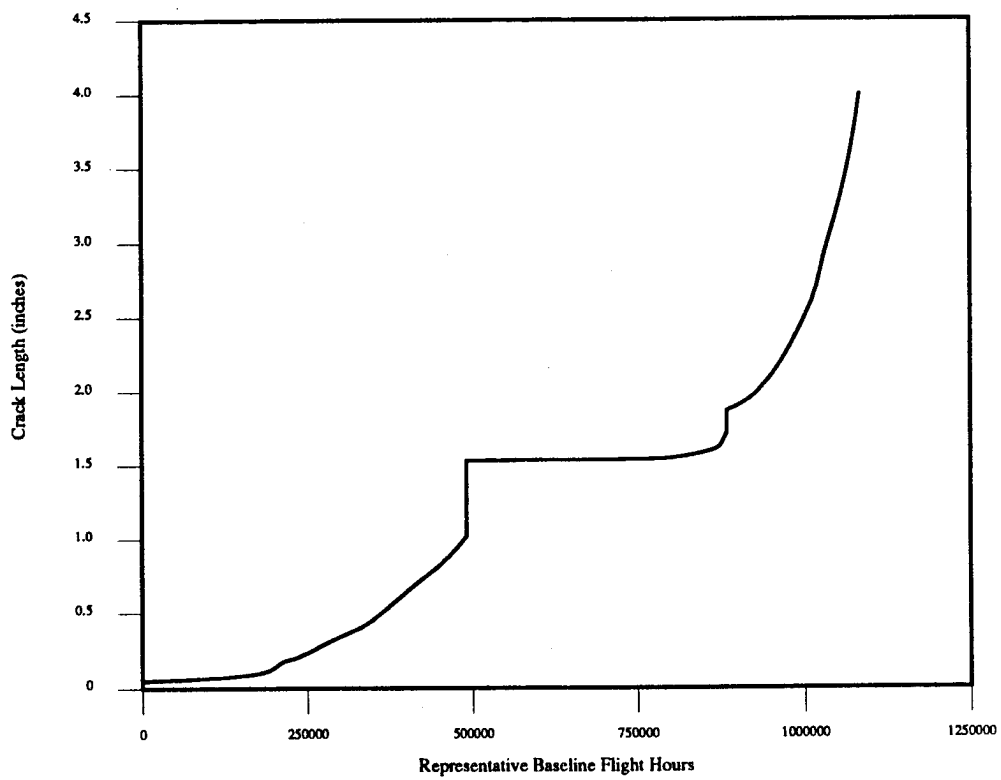
Figure 3.4: Crack Growth Curve for Analysis Case 4

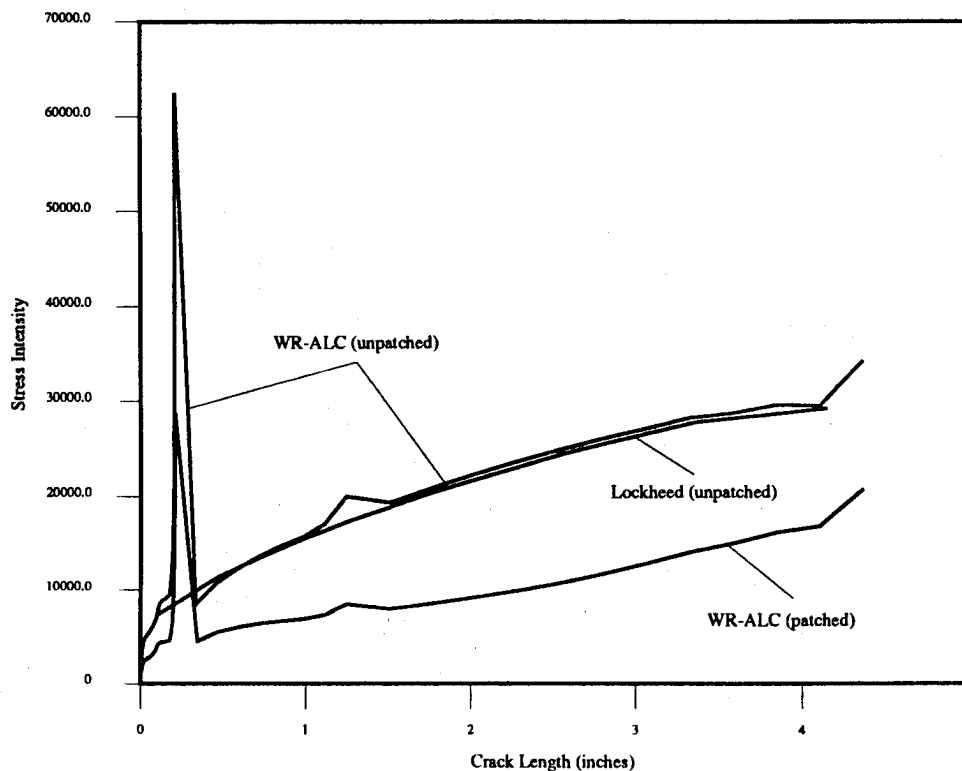
Figure A1: Crack Profile A Stress Intensities

where: K_I = Mode 1 Stress Intensity Factor ($\text{psi}(\text{in})^{0.5}$)
 σ = Applied Stress (10,000 psi)
 a = Crack Length (inches)

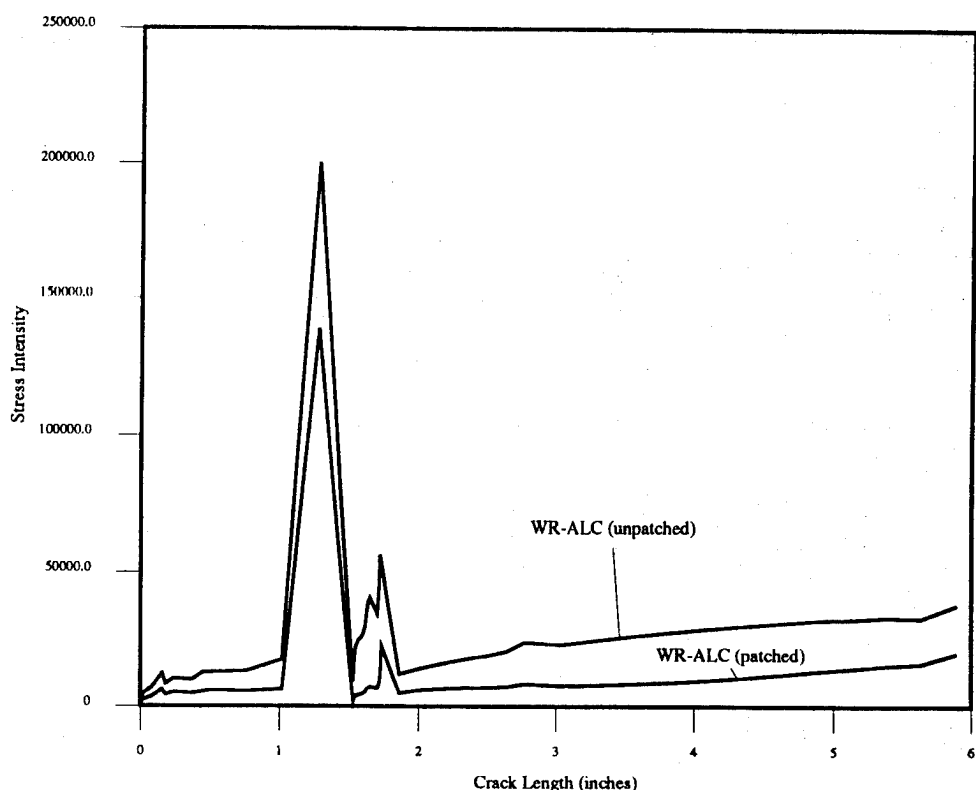
Figure A2: Crack Profile B Stress Intensities

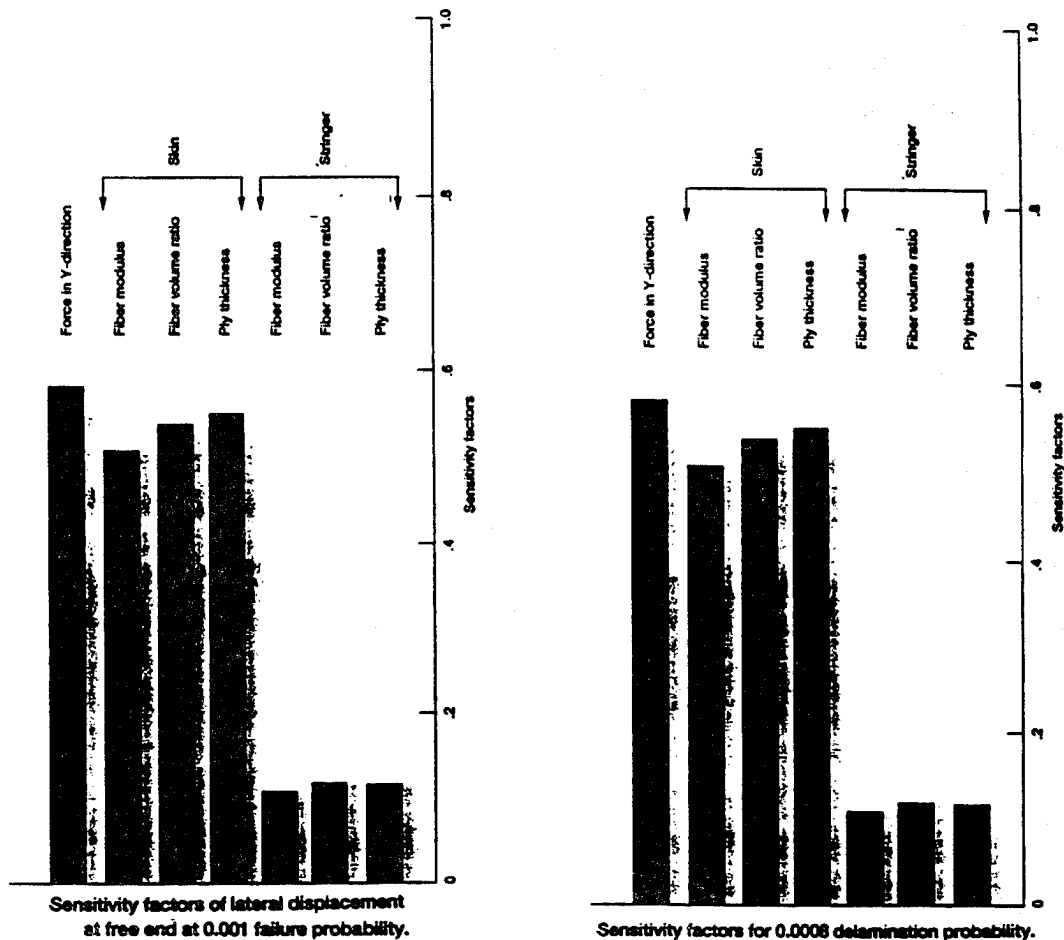
Fig. 4. Sensitivity factors are both large and variable in composite materials.

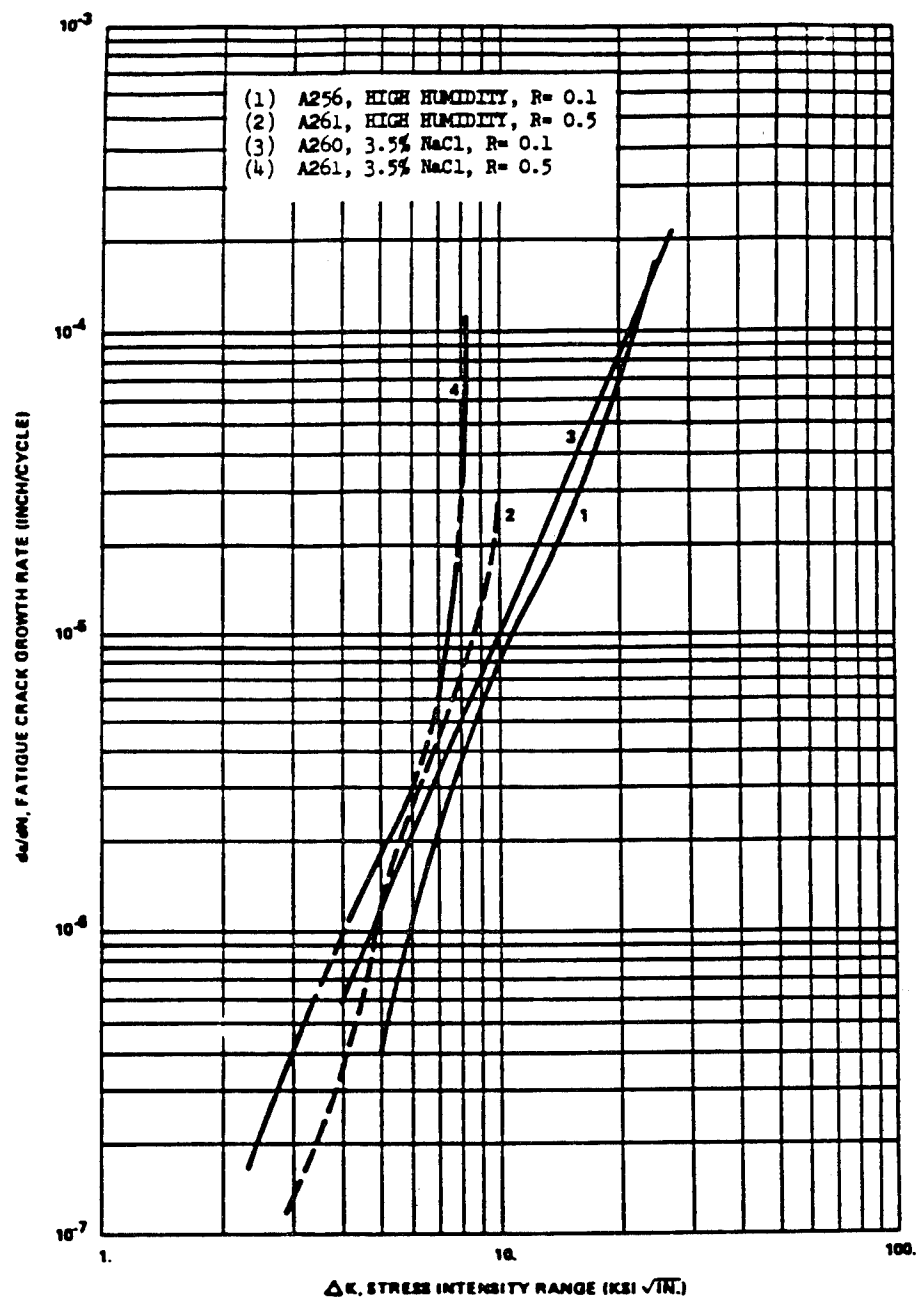
Fig. 2. Effect of stress ratio for 3/8 inch 2024-T851 CCT specimens under 20 Hz, WR orientation.

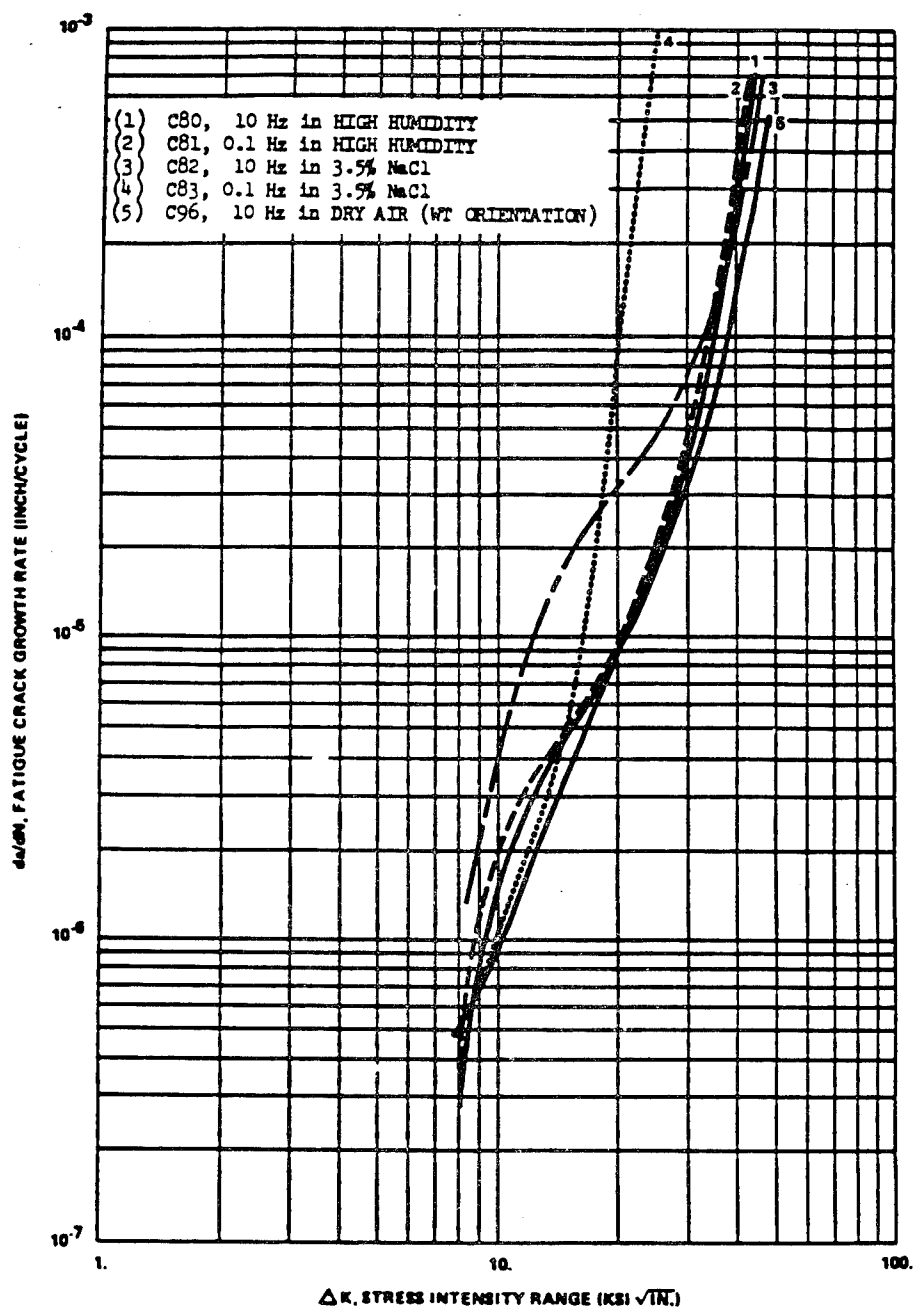
Fig. 4. Fatigue crack propagation results for 3/8 inch Ti-6Al-6V-2Sn (STOA) PTC specimens, $R = 0.1$, RT orientation.

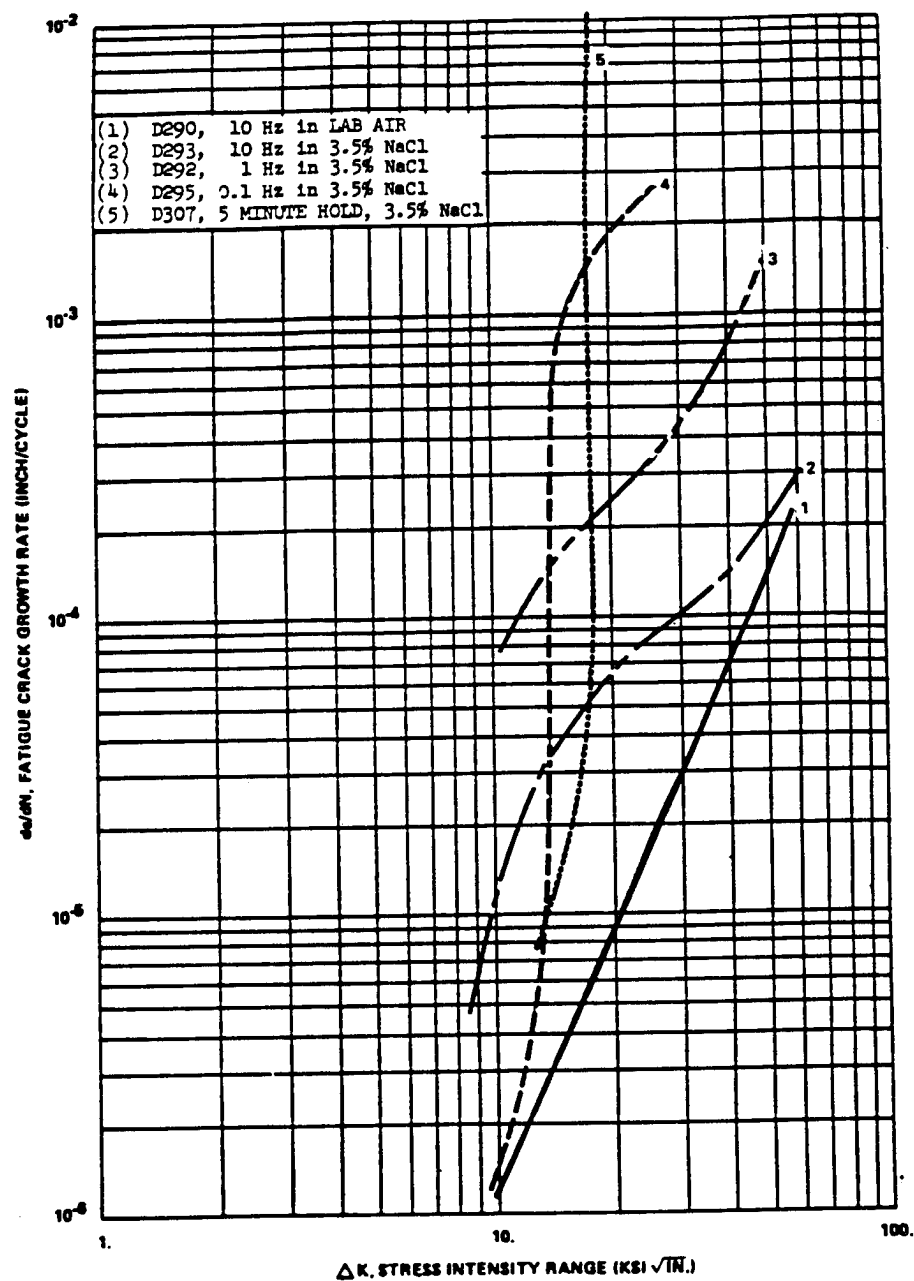
Fig. 5. Effect of frequency for 3/8 inch Ti-6Al-4V (RA) WOL specimens under $R = 0.1$ in WR orientation.

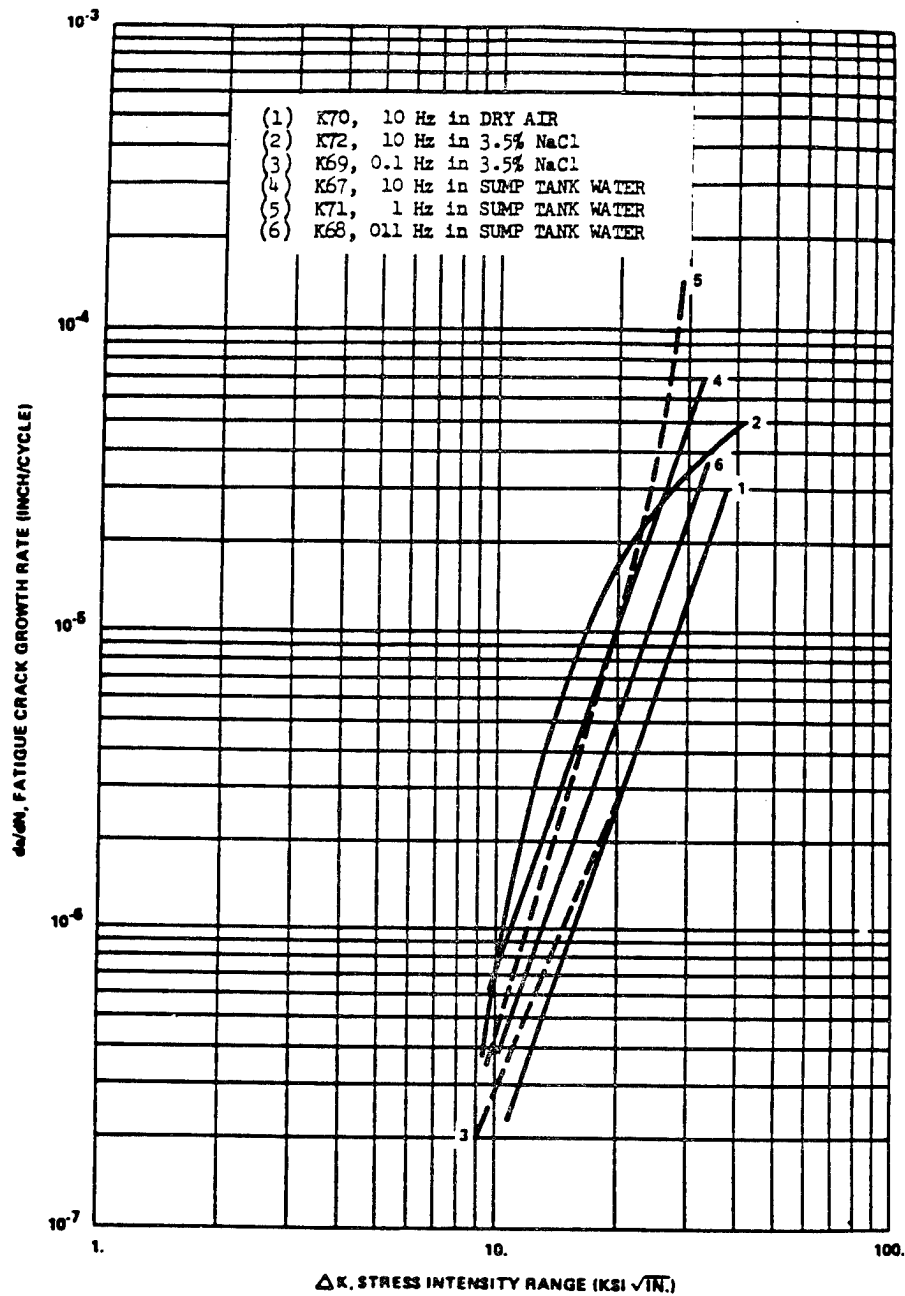
Fig. 6. Comparison of corrosion fatigue results in sump tank water and in 3.5% NaCl solution for 5/8 inch Ti-6Al-4V (Beta) WOL specimens, $R = 0.1$ in WR orientation.

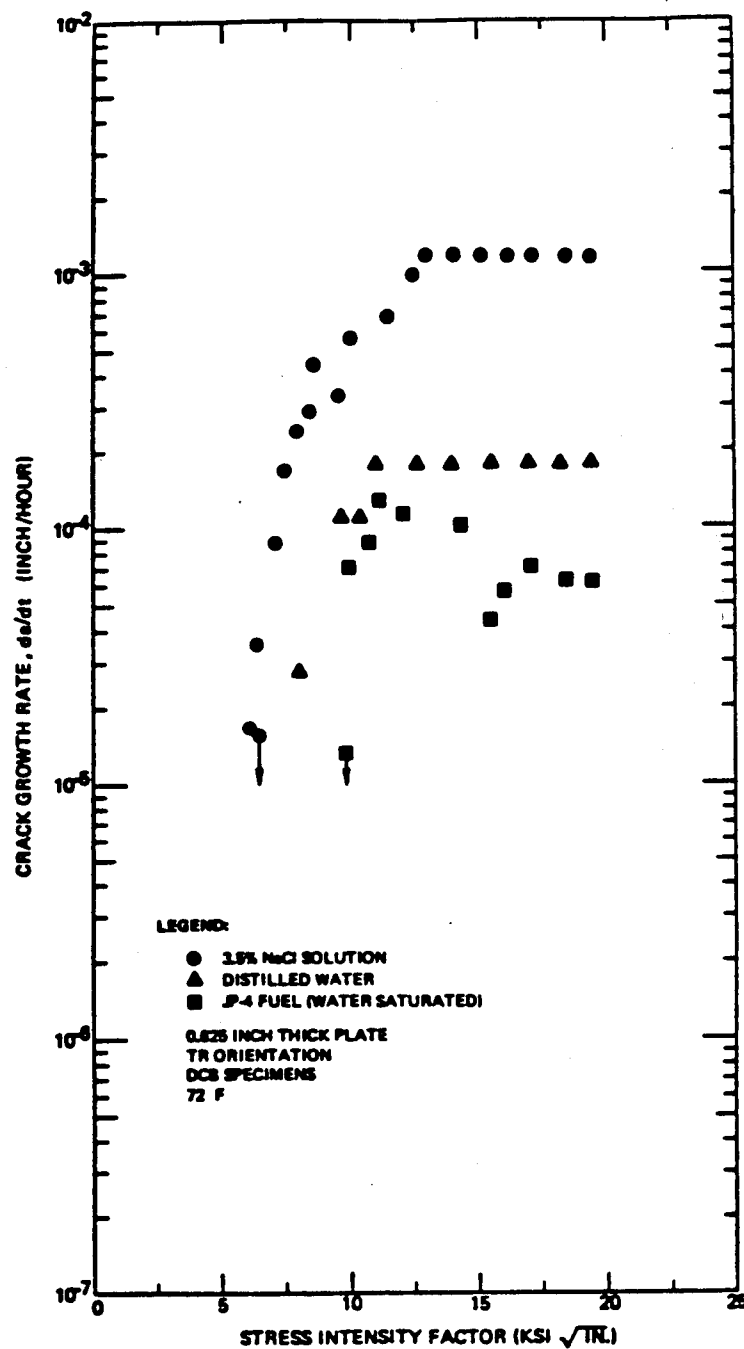
Fig. 7. Stress corrosion cracking velocity data for 7075-T651 aluminum alloy (14).

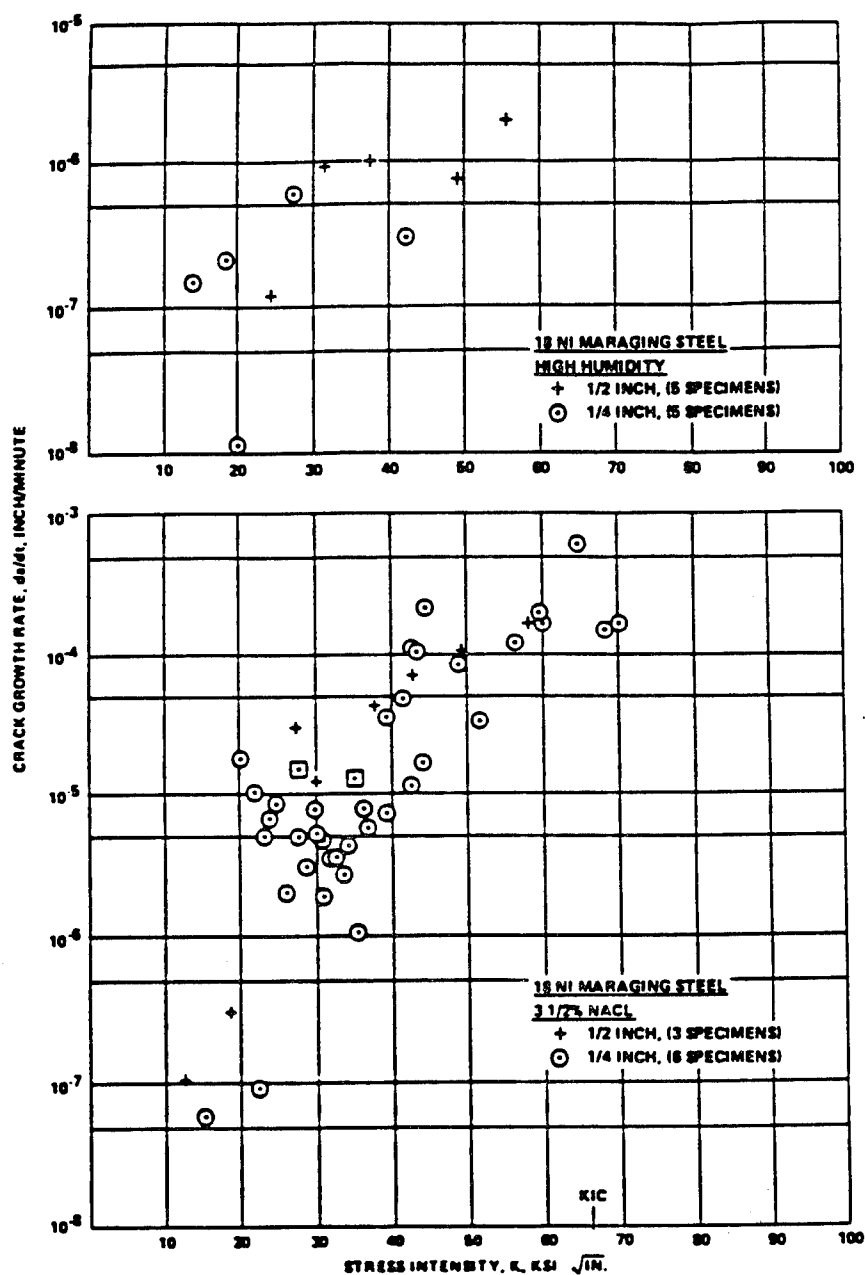
Fig. 8. Stress corrosion crack growth rate behavior of 18Ni Mar-aging steel (250 Grade) CT specimens in WR orientation.

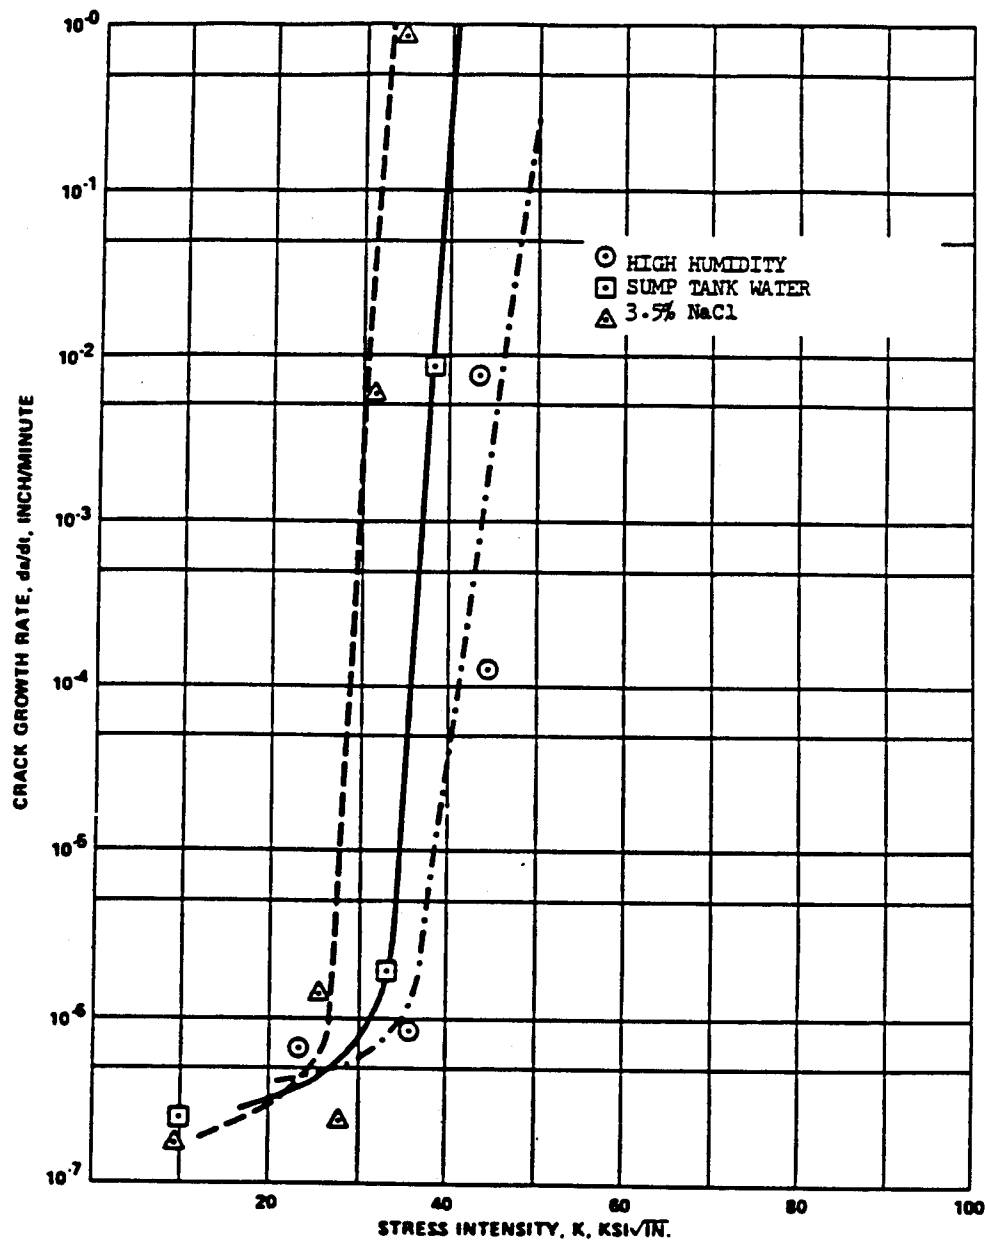
Fig. 9. Stress corrosion crack growth rate for 3/8 inch Ti-6Al-6V-2Sn (STOA) plate material.

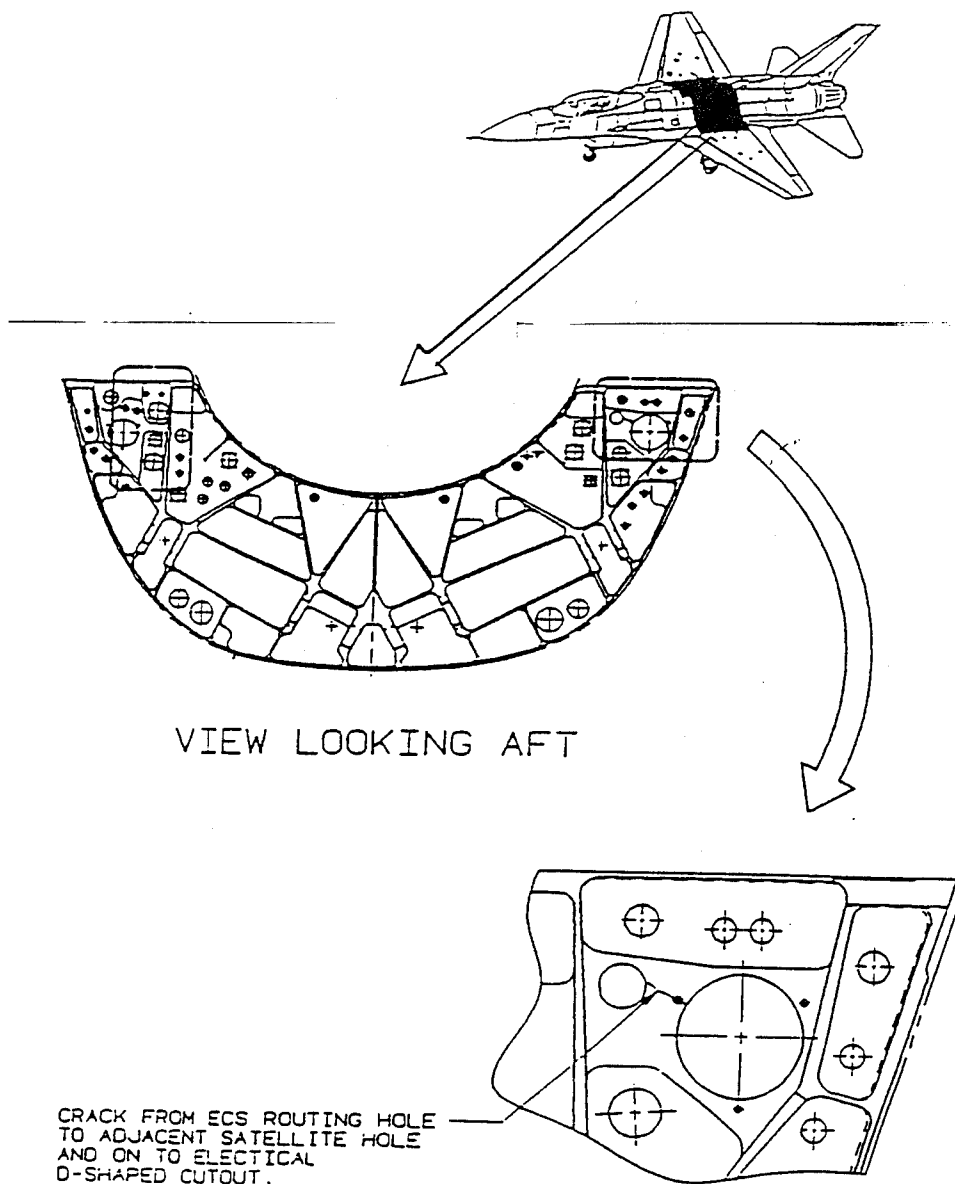
FIG. 1 - General description of the lower bulkhead panel cracking problem.

The center fuselage bulkhead is one of the most critical airframe components of the F-16, which reacts the wing bending moment, pitch moment and shear load. The lower bulkhead is a one-piece forging incorporating stiffeners and shear panels, as seen in Figure 1. Also depicted in Figure 1 is the critical panel which developed the cracks.

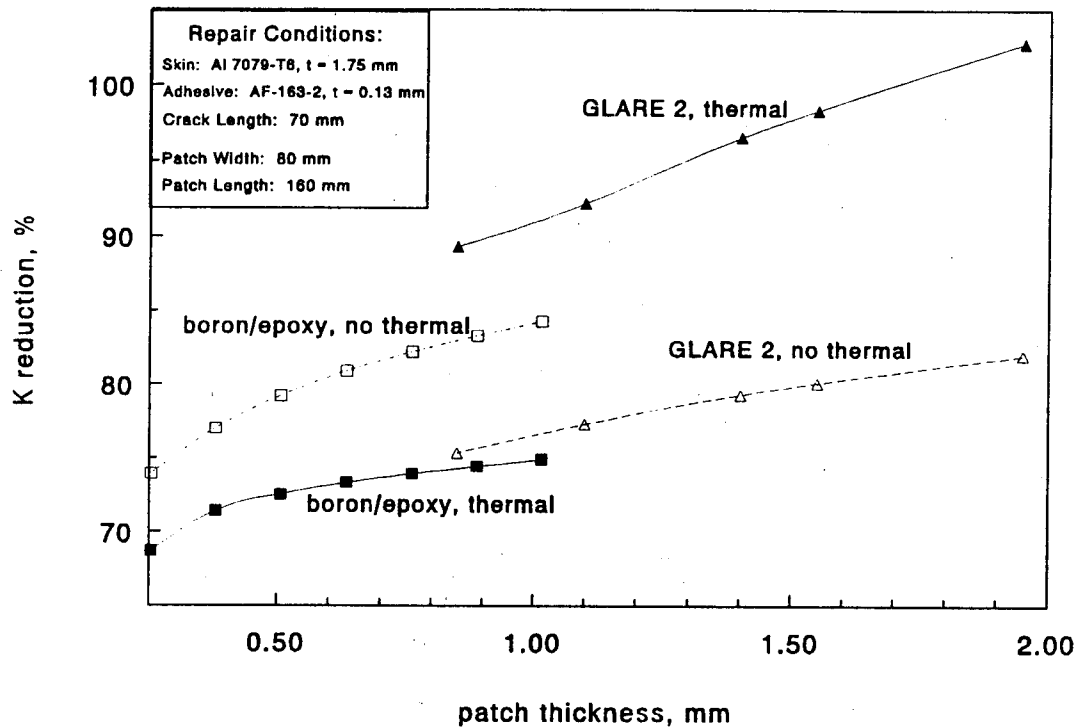
Figure 1. Comparison of reduction in stress intensity factor for bonded GLARE™ 2 and boron patches, with and without considering thermal effects [5].

unidirectionally reinforced glass/epoxy/aluminum hybrid GLARE™ 2. While boron's CTE is about 1/6 that of aluminum, GLARE™ 2 has a CTE approximately 2/3 of aluminum.
